Preliminary Road Safety Analysis Report
For
Cleary Blvd from Hiatus Road to North University Drive

November 2022

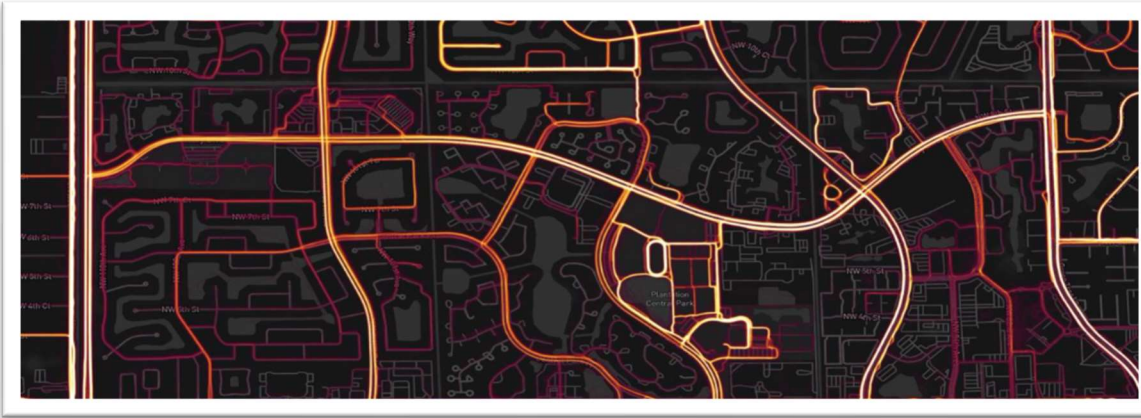
Figure 3: Strava bike volumes. Cyclists use Cleary Blvd to access parks and nearby commercial uses.

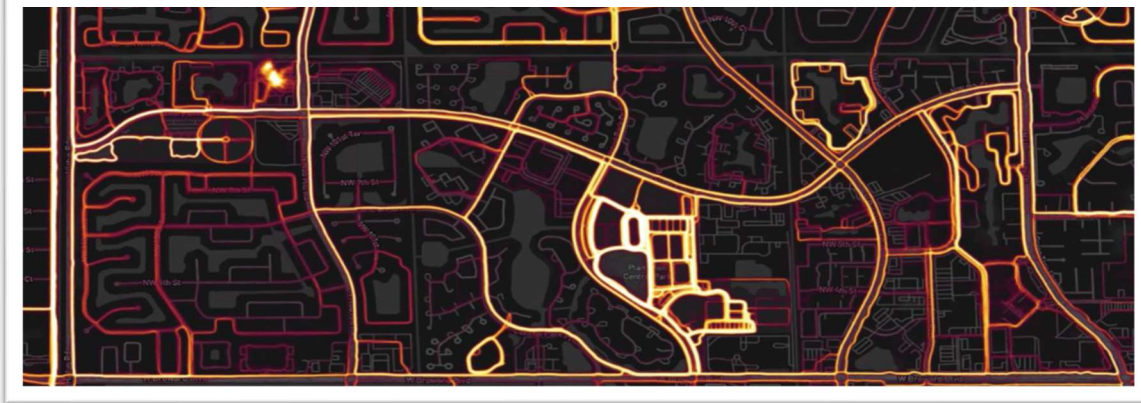
Figure 4: Strava pedestrian volumes. Pedestrian volumes are concentrated adjacent to parks.

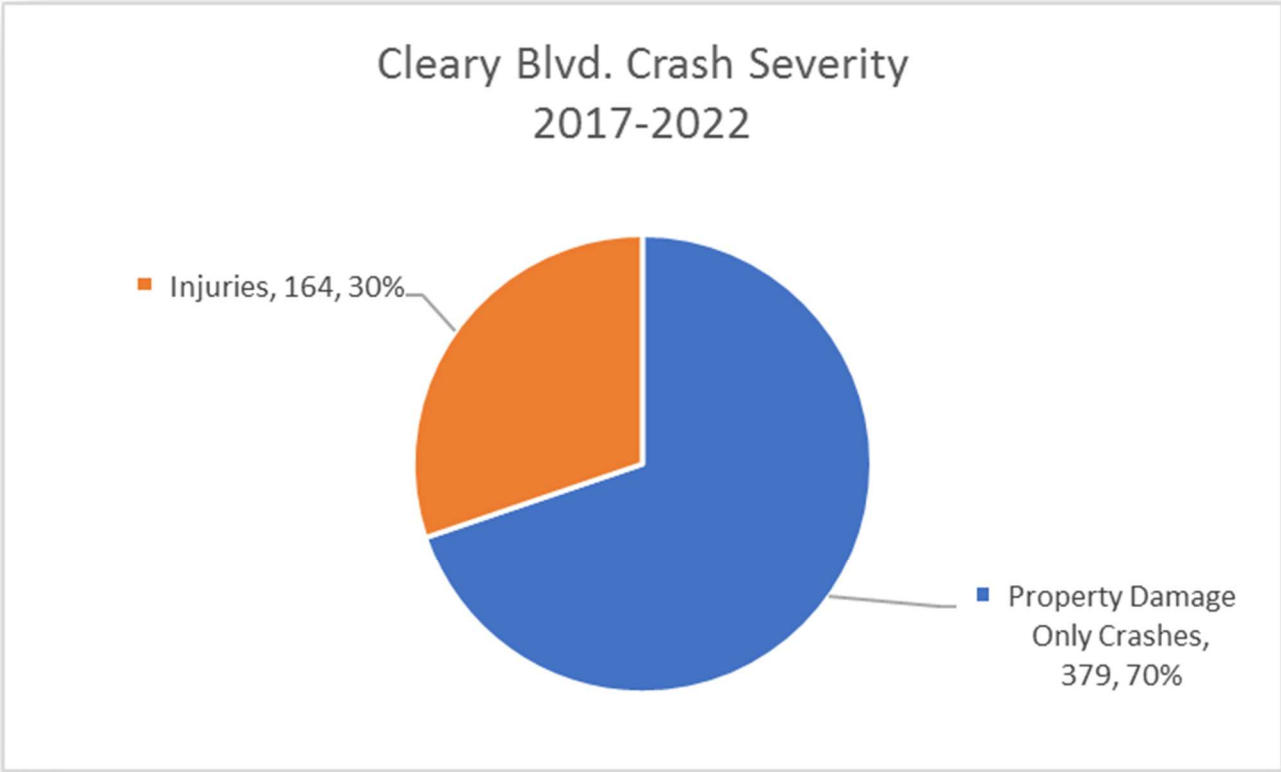
Figure 5: Cleary Blvd crash severity pie chart

543 total crashes were recorded in Signal 4 between 2017 and late-2022 within the project area. Of those, 164 involved injuries, and none involved fatalities. The heaviest concentration of total crashes, as well as the most injury crashes, occurred at the intersections of S. Hiatus Road, Nob Hill Road, N. Pine Island Road, and N. University Dr. There were 5 pedestrian crashes and 10 bike crashes during this time period as well, most of which were concentrated at major corridor intersections. 41 crashes occurred during rainy weather, also concentrated at major intersections.

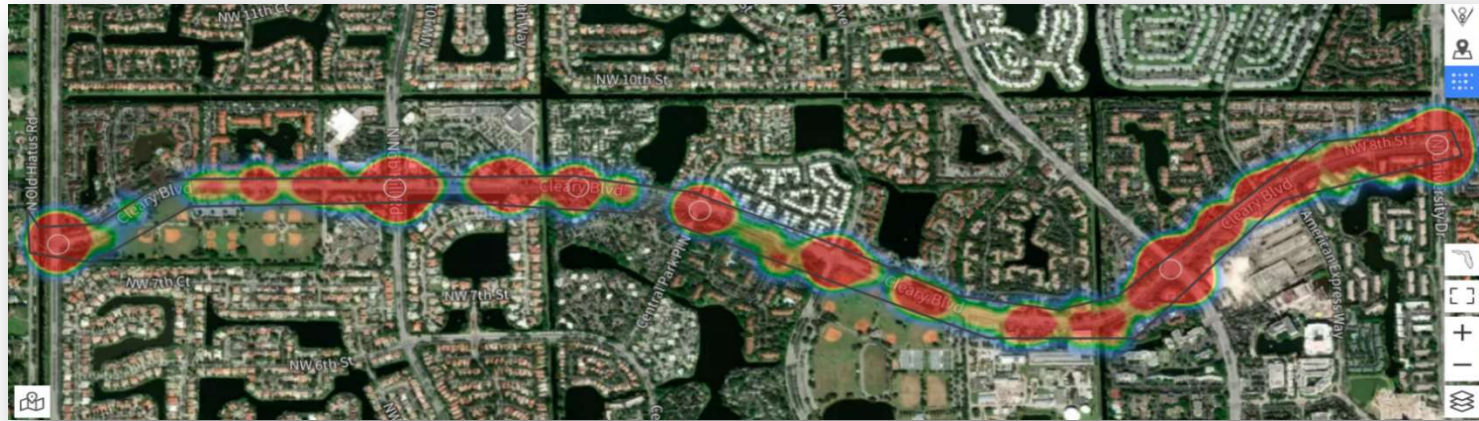
Figure 6: Heat map of all crashes on corridor

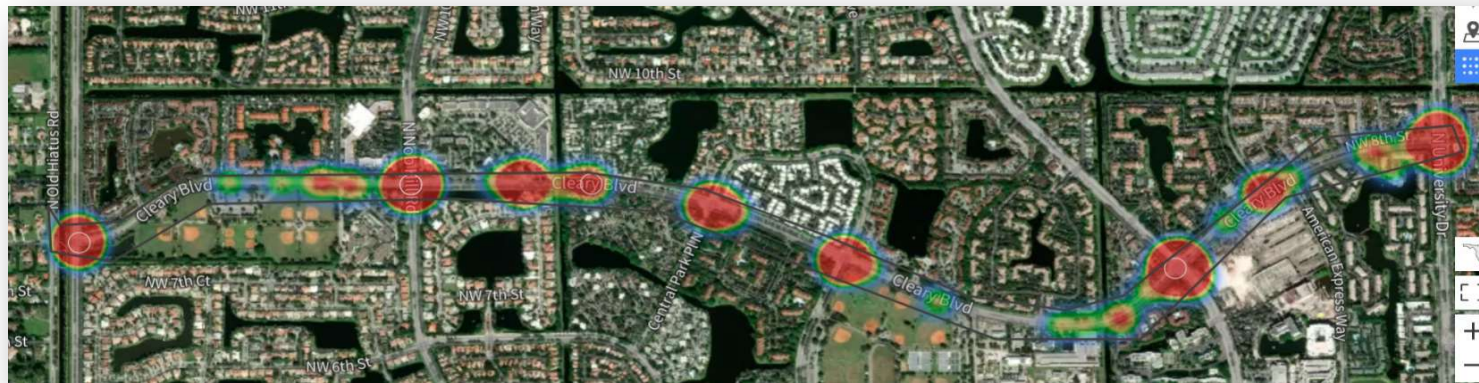
Figure 7: Heat map of all injuries on corridor

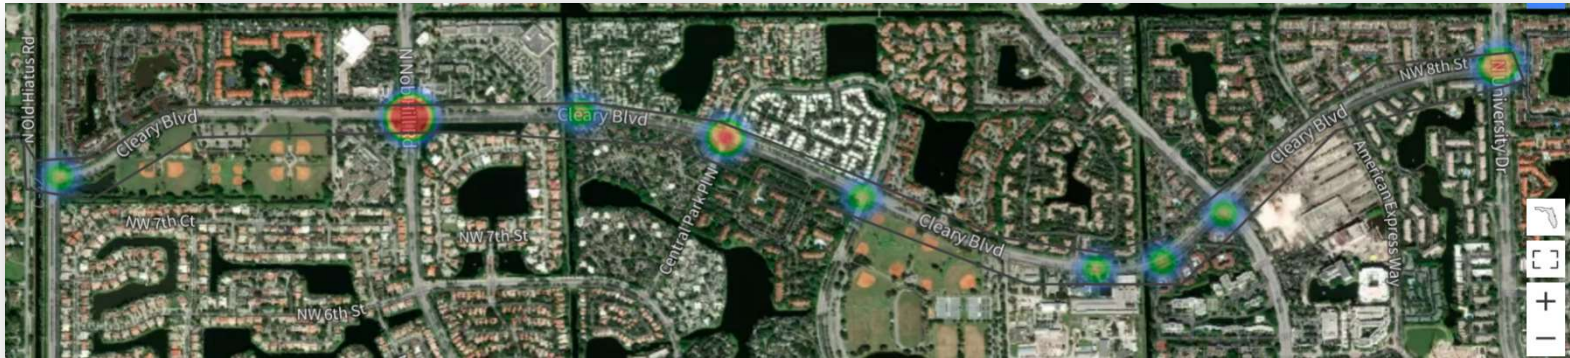
Figure 8: Heat map of all bike and pedestrian crashes, almost all of which involved injuries.

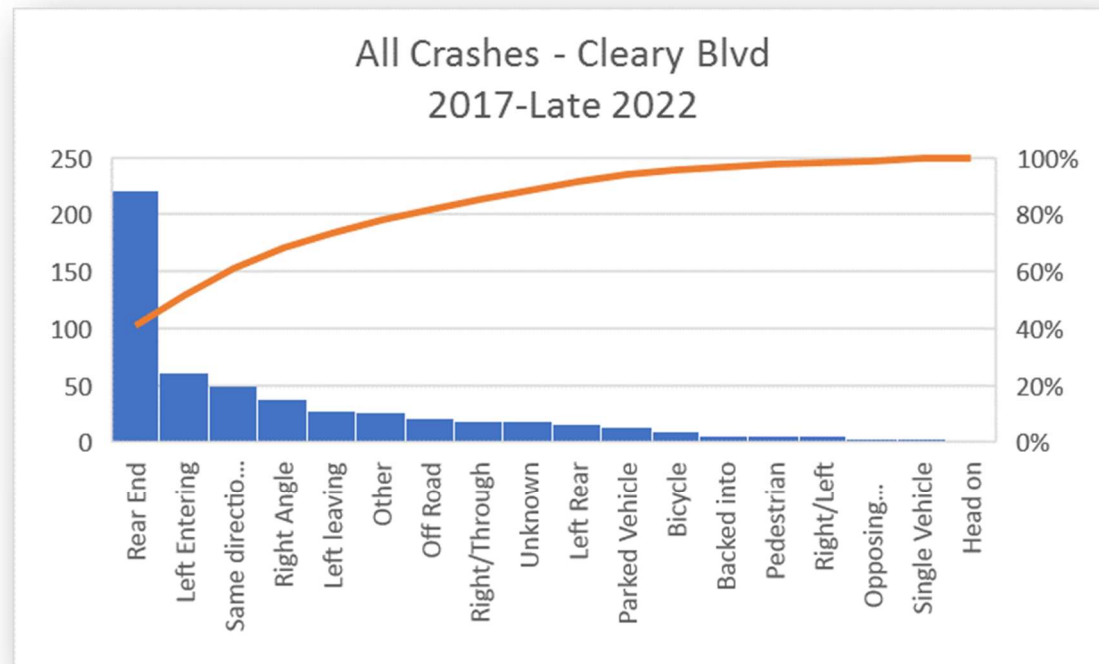
By far the most dominant crash type on Cleary Blvd are rear end crashes, followed by left entering crashes and same direction sideswipes.

Figure 9: Crash types - all crashes for entire corridor

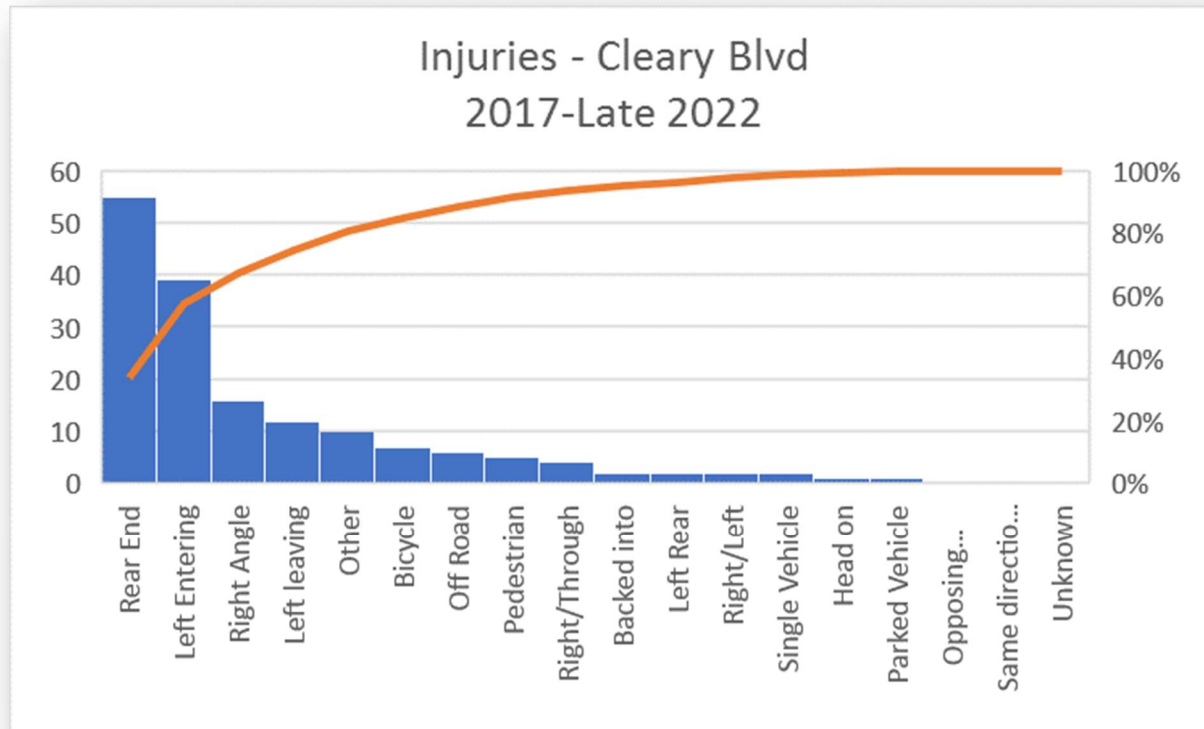
Rear end and left entering crashes made up the largest share of crashes which involved injuries.

Figure 10: Injury only crashes for entire corridor

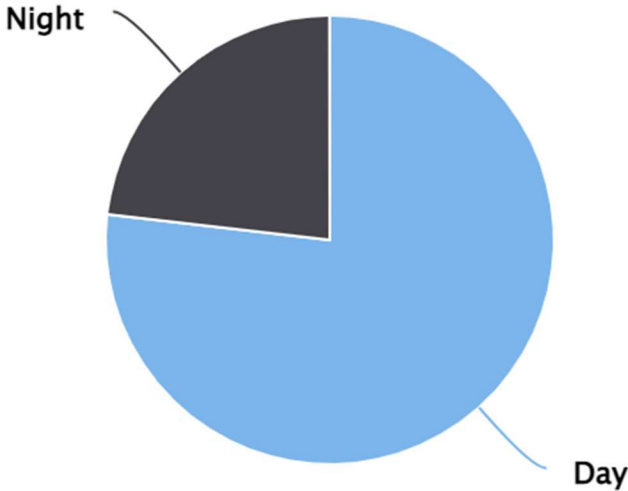
Figure 11: About 23% of crashes occurred at night

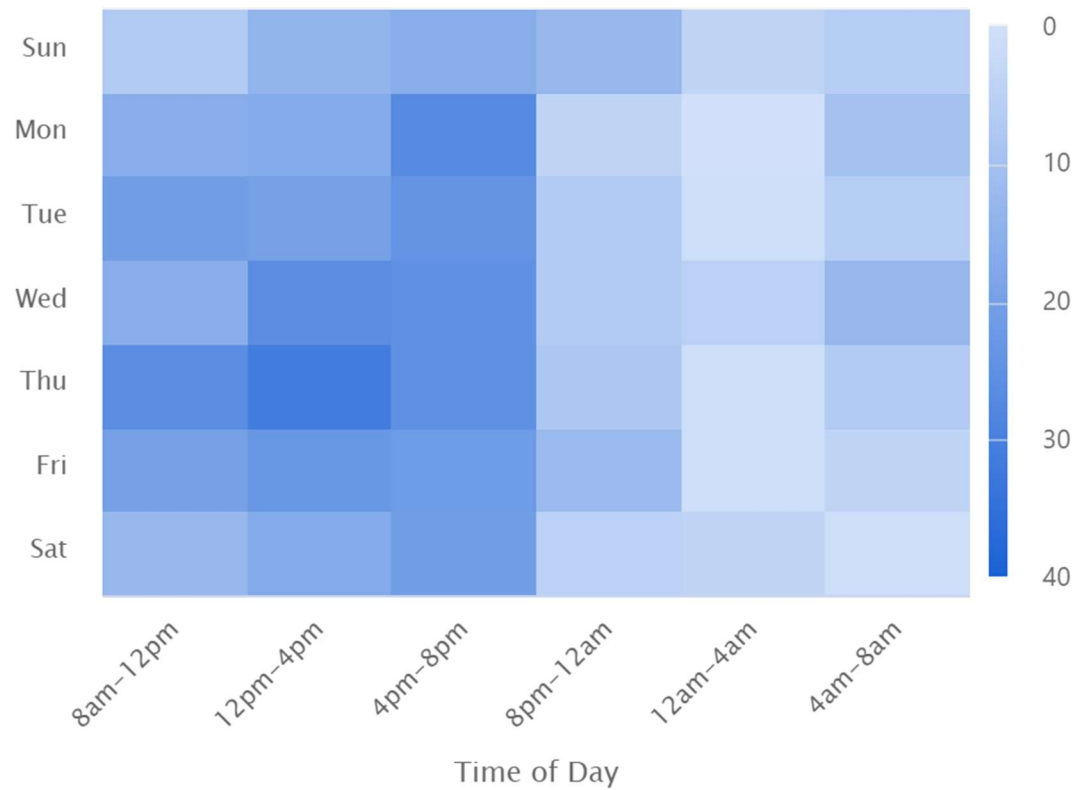
Figure 12: Crashes by time of day

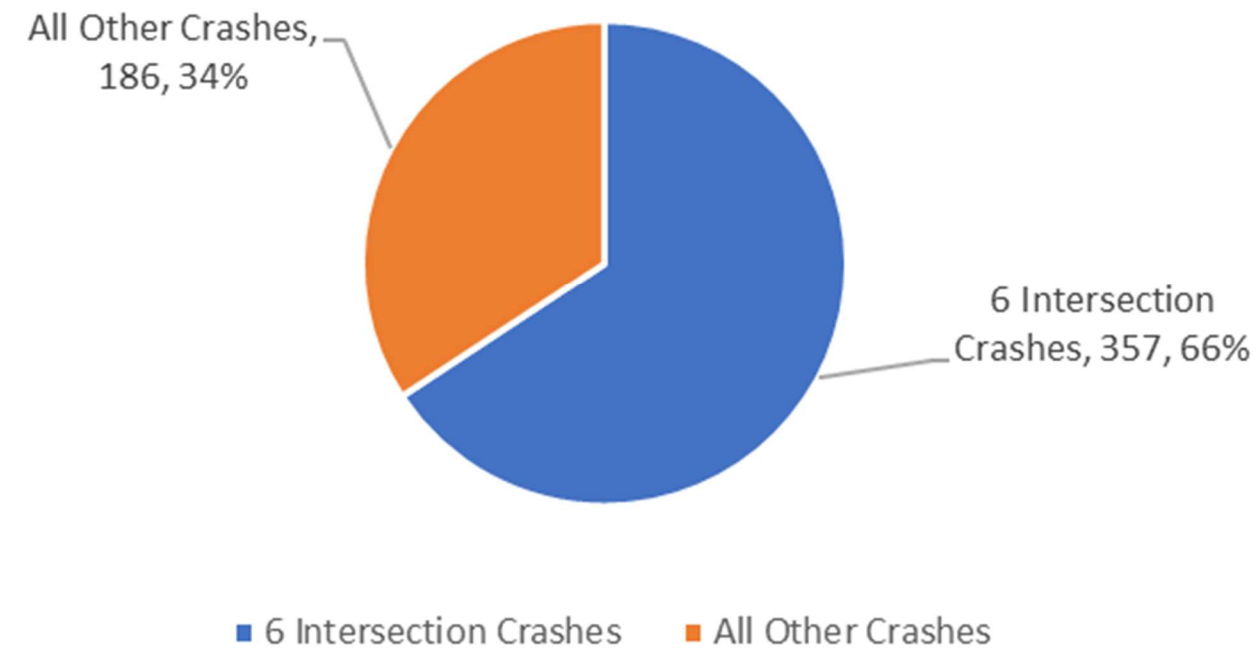
6 major signalized intersections accounted for 357 crashes on the corridor, or about 66% of the total corridor crashes. Of these intersections, crashes are concentrated at 3 locations on Cleary Blvd.: **University Drive, Nob Hill Road, and Pine Island Road. A combined 278 crashes occurred at these 3 intersections, making up about 50% of the total crashes on the corridor between 2017 and late 2022.** These 3 intersections also had 81 injuries during the same time period, making up about 50% of all the injuries on the corridor.

Figure 14: Crashes at the 6 major Cleary Blvd intersections vs. crashes at all other locations

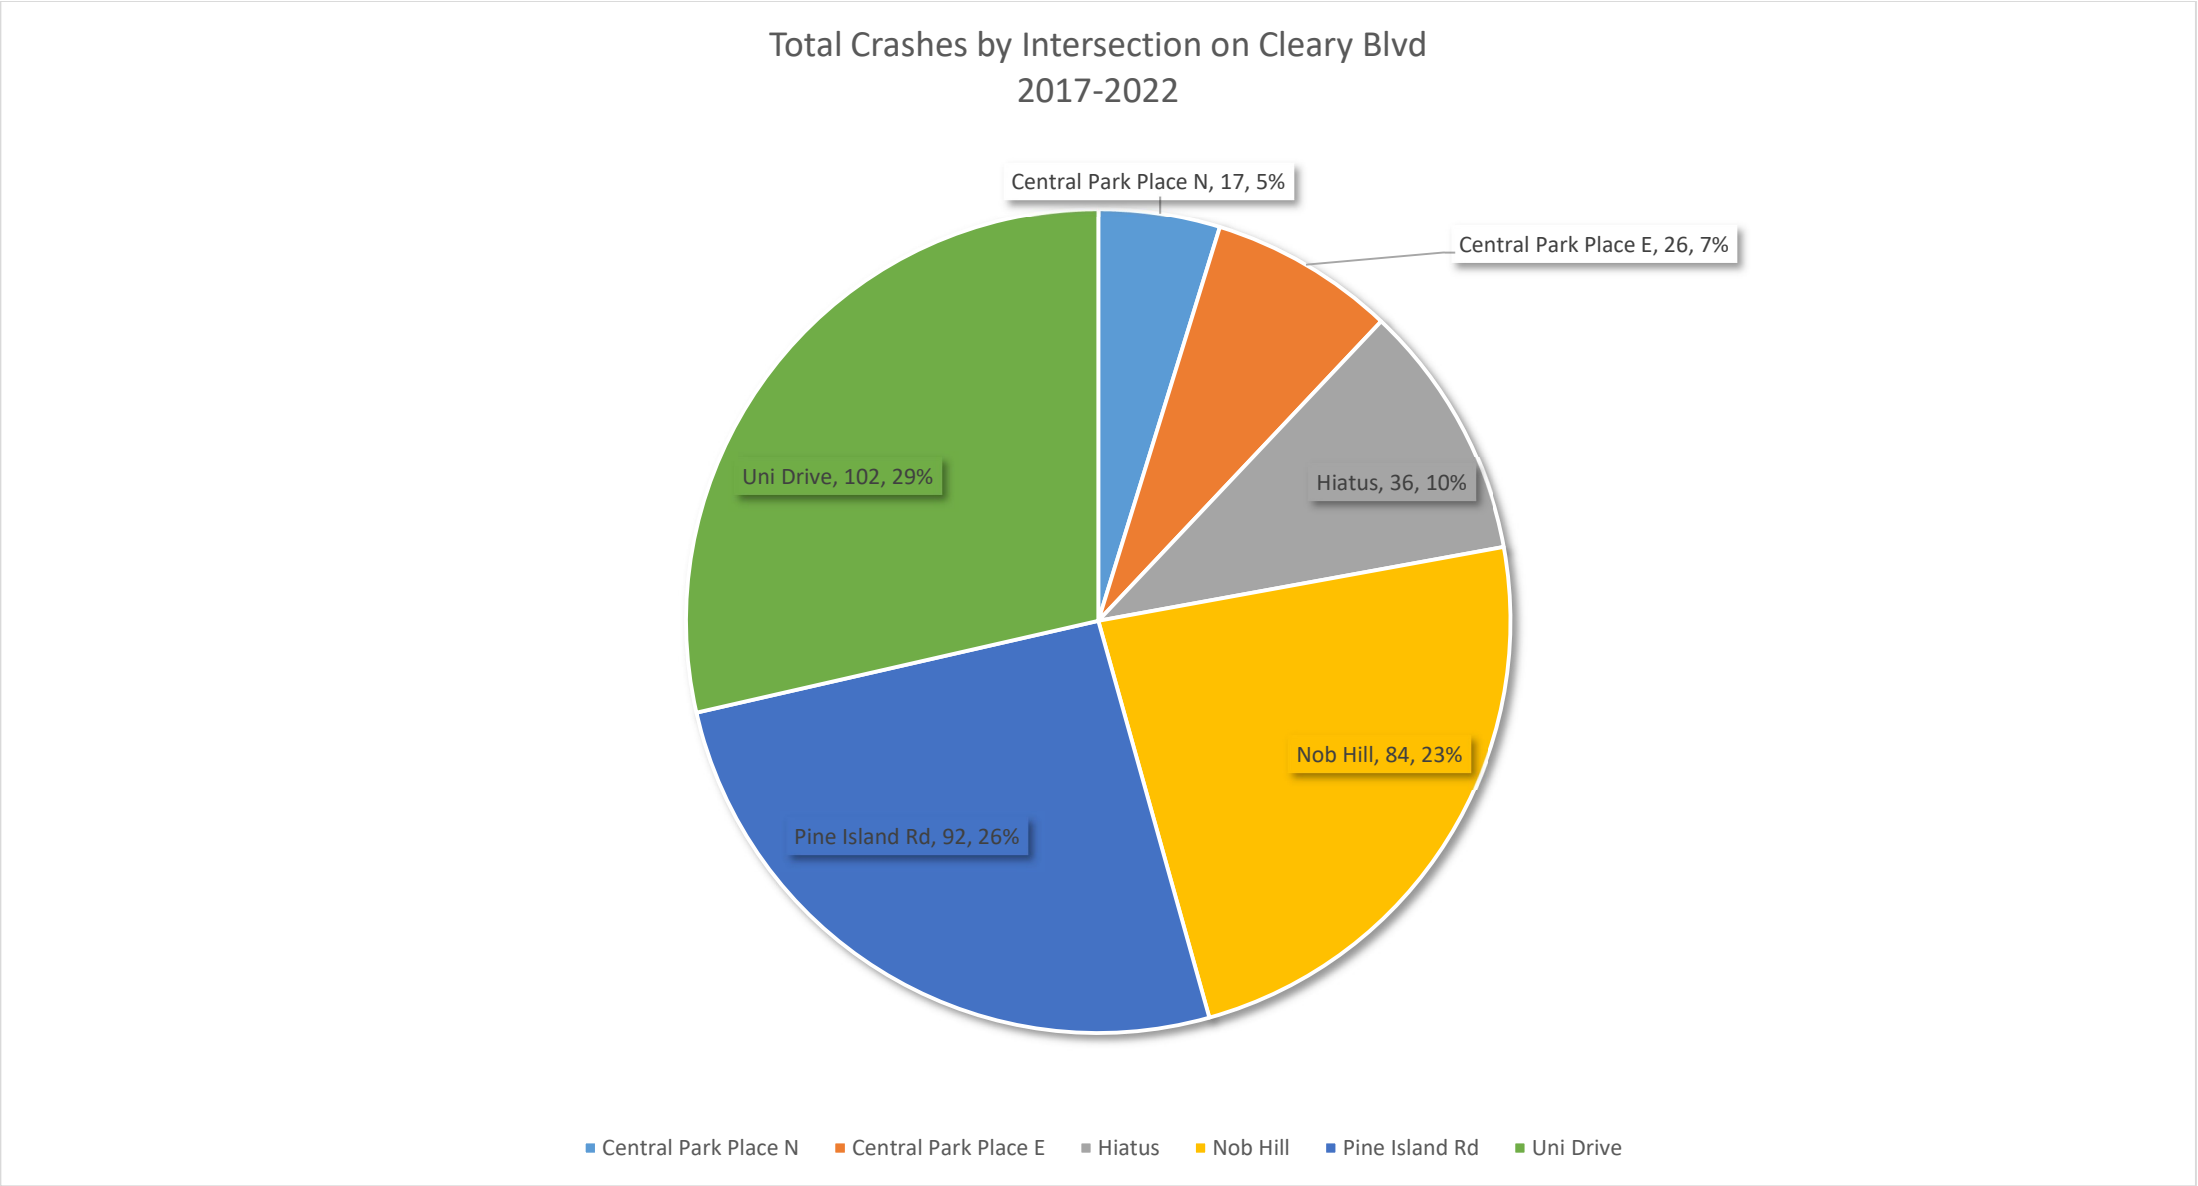
Of the 6 signalized intersection locations, University Drive saw the most total crashes, accounting for 29% of all crashes of these 6 intersections.

Figure 15: Total crashes by major intersection

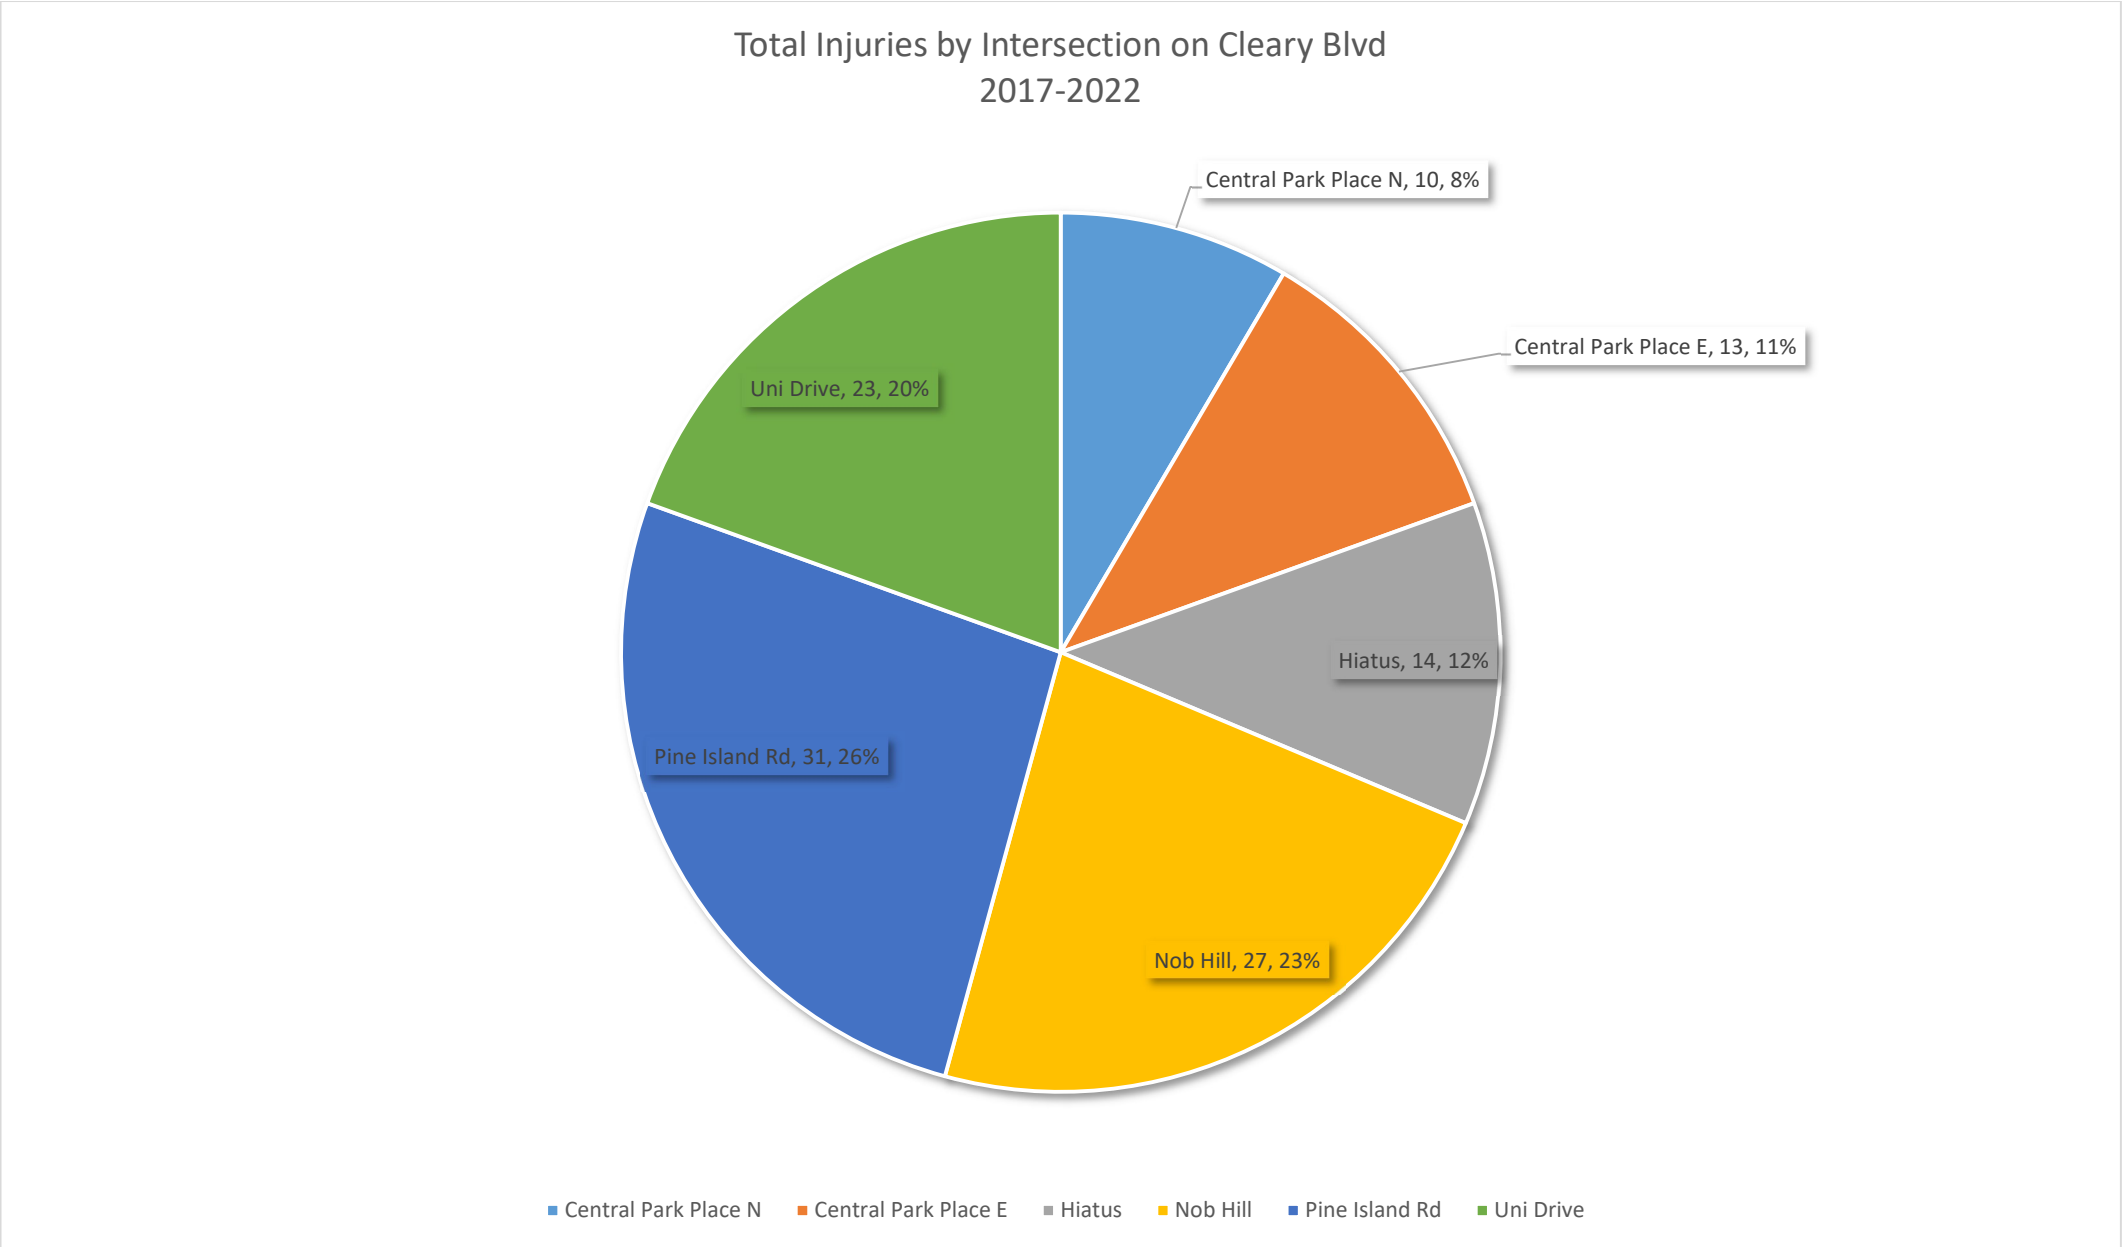
Of the same 6 intersections, Pine Island Road saw the most injuries (31), making up 26% of injuries of these intersections.

Figure 16: Total injuries by major intersection

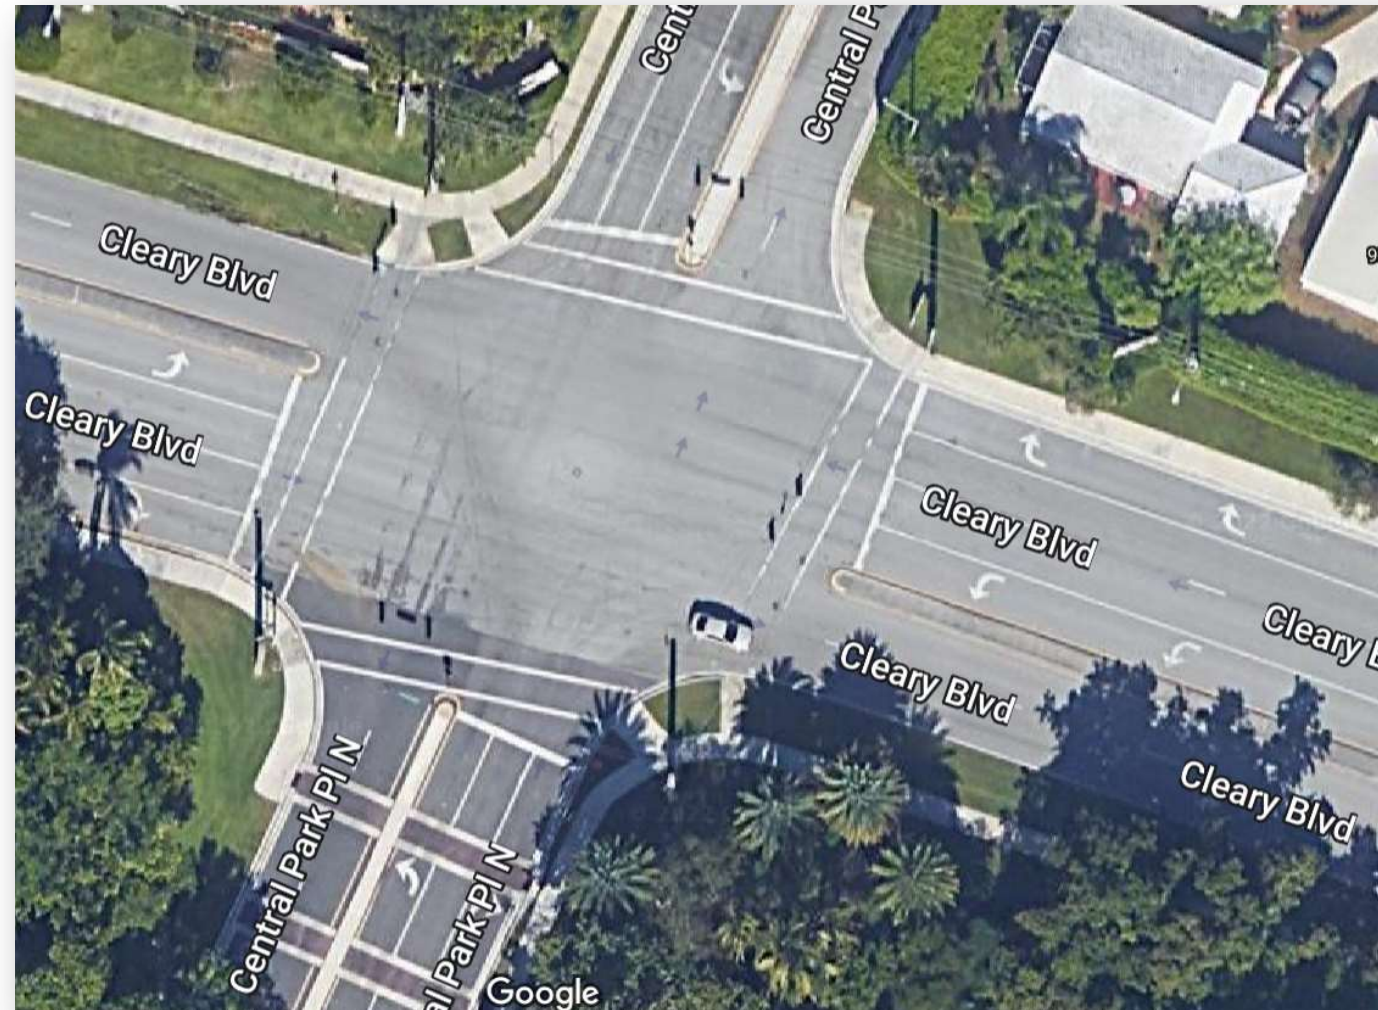
The intersection of Cleary Blvd. and Central Park Place N had 17 crashes during the study period, with a relatively even balance of crashes consisting of right angle, rear end and left entering crashes. The intersection is signalized with span wire signals, dedicated left turn lanes, but lacks left turn signals.

Figure 17: Aerial of Central Park Pl N intersection

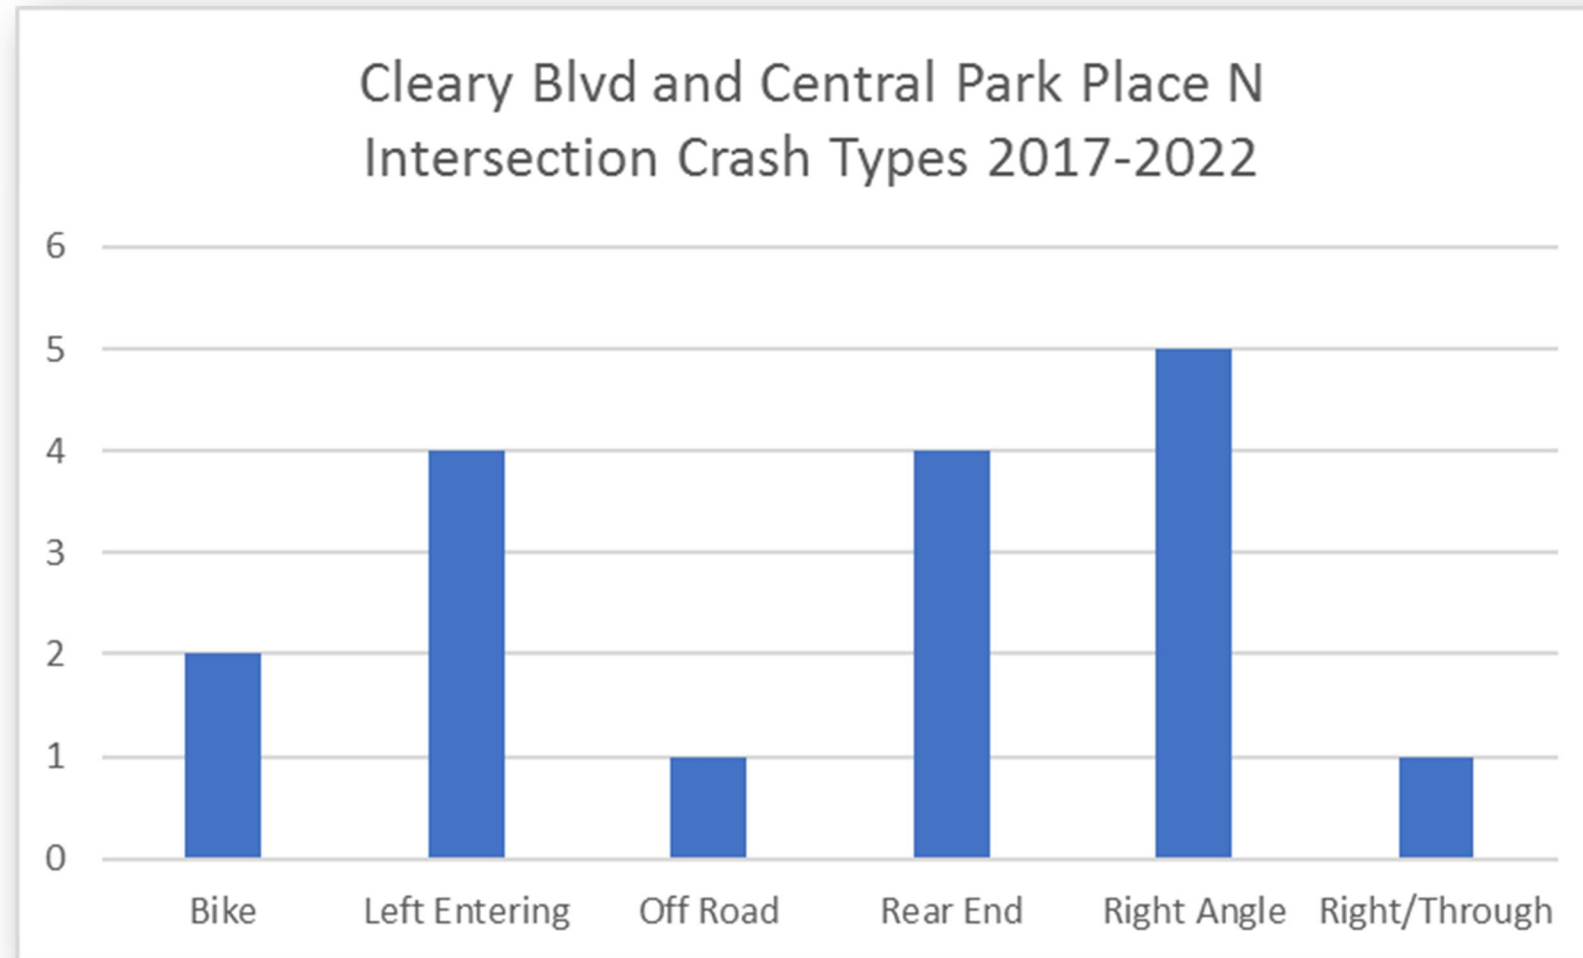
Figure 18: Crash types for Cleary Blvd and Central Park Place N intersection

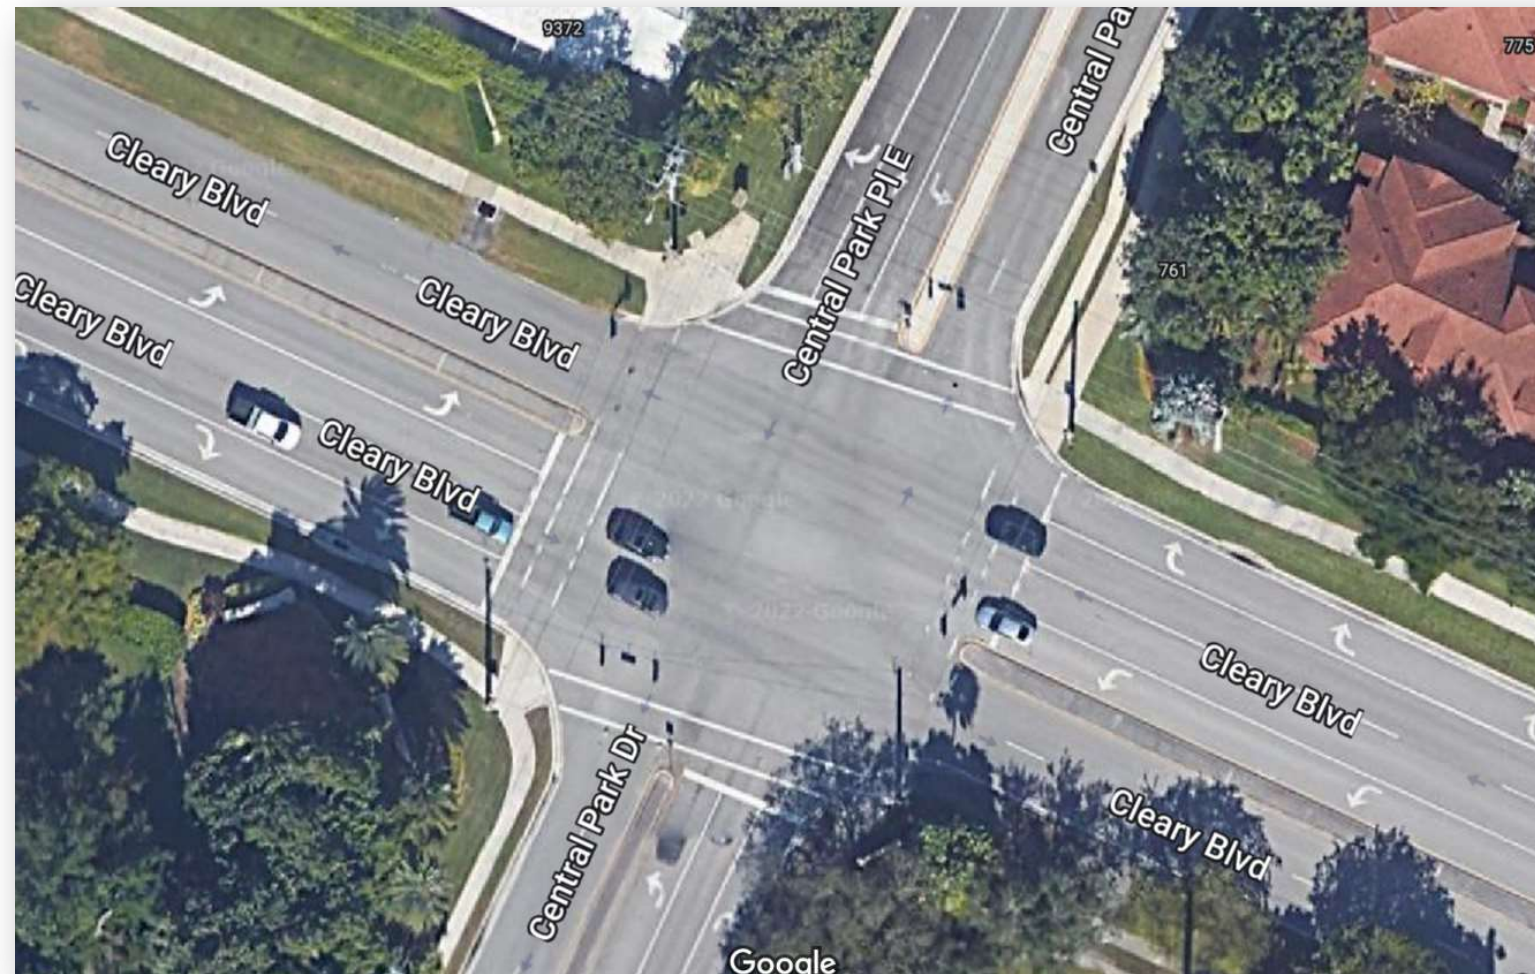
The signalized intersection of Central Park Place East saw 26 total crashes, with right angle and left entering crashes making up a large percentage of crashes. The intersection has a span wire signal and dedicated left turn lanes. There are no left turn signals at the intersection.

Figure 19: Aerial of Central Park Place E intersection

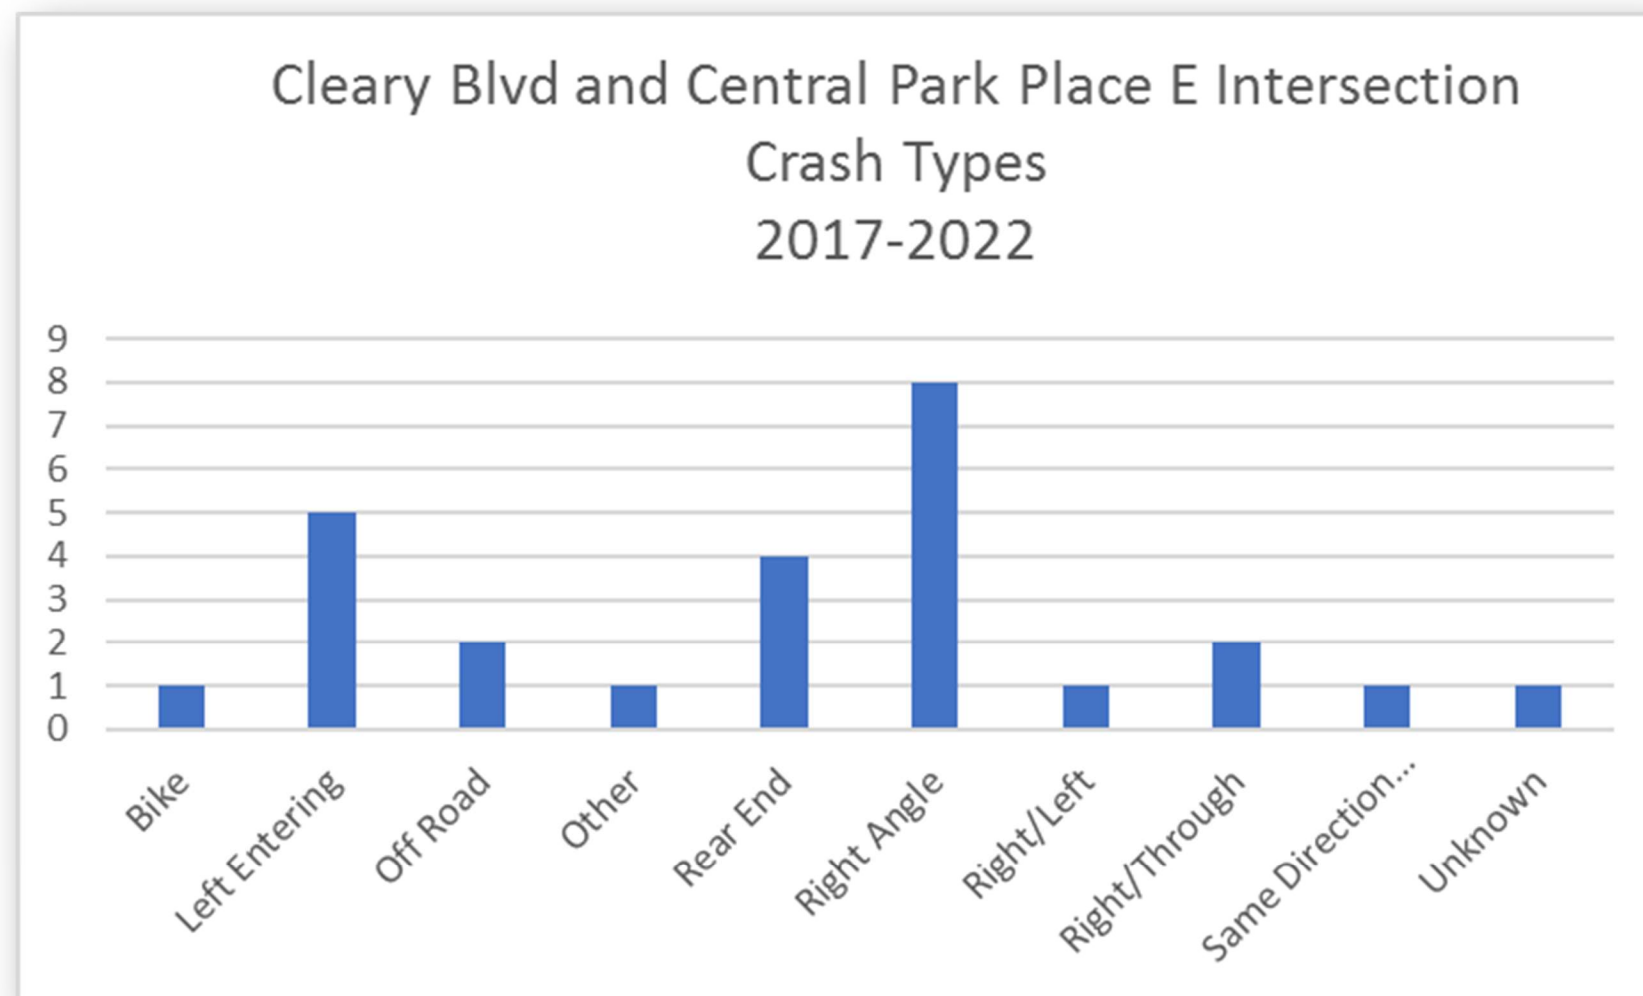
Figure 20: Crash types for Cleary Blvd and Central Park Place E intersection

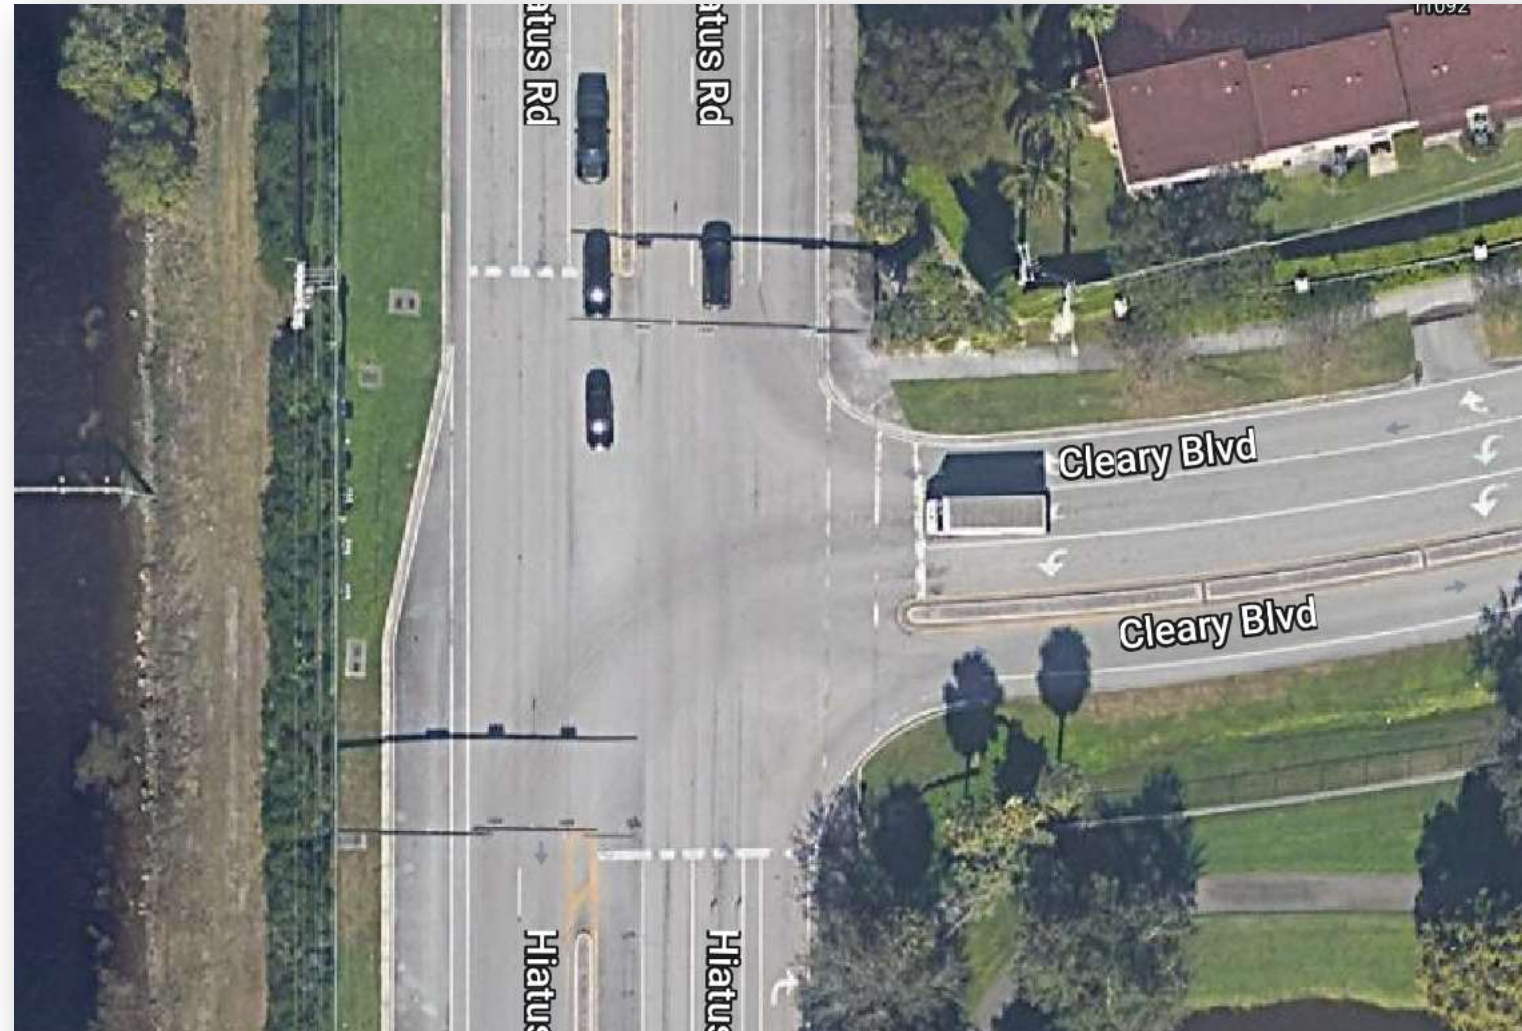
There were 36 crashes at the Hiatus Road intersection during the study period, with rear end and left entering crashes making up the vast majority of total crashes. There are relatively new mast arm signals at the intersection. There is no left turn signal going SB on Hiatus Rd. Hiatus Rd. is a County roadway.

Figure 21: Aerial of Hiatus Rd. intersection

8. Lack of street and pedestrian lighting at Hiatus Road intersection
9. Some pavement markings are worn on the west side of the corridor.

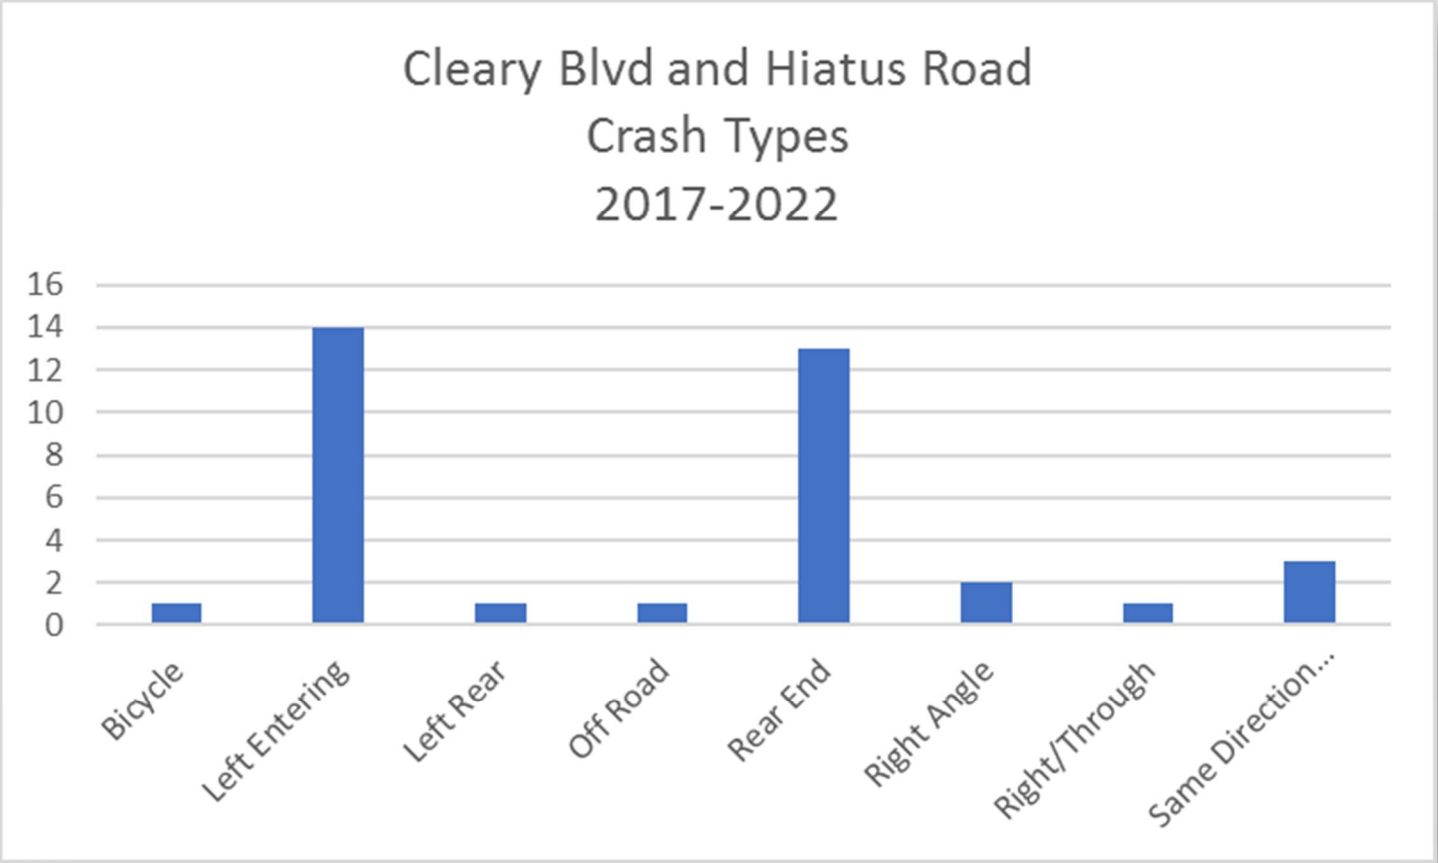
Figure 22: Crash types for Cleary Blvd and Hiatus Road intersection
