Preliminary Road Safety Analysis Report
For
Cleary Blvd from Hiatus Road to North University Drive

November 2022

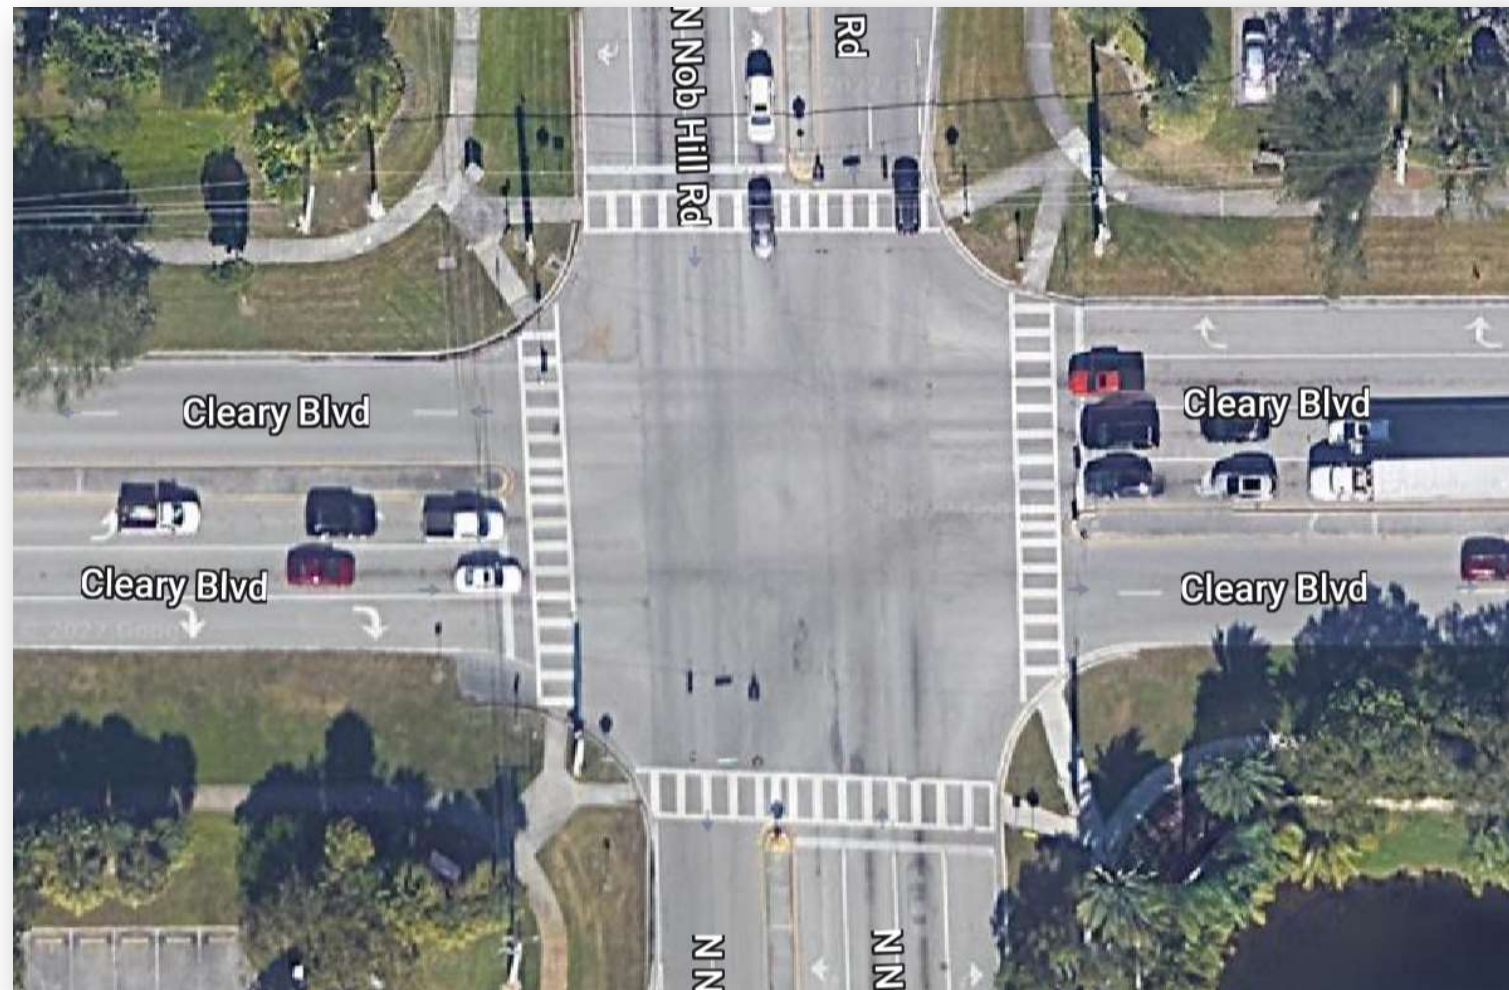
There were 84 total crashes at the Nob Hill Rd. intersection. Rear end crashes made up the vast majority of crash types. There is a span wire signal at the intersection with left turn signal heads on all 4 legs.

Figure 23: Aerial of Nob Hill Road intersection

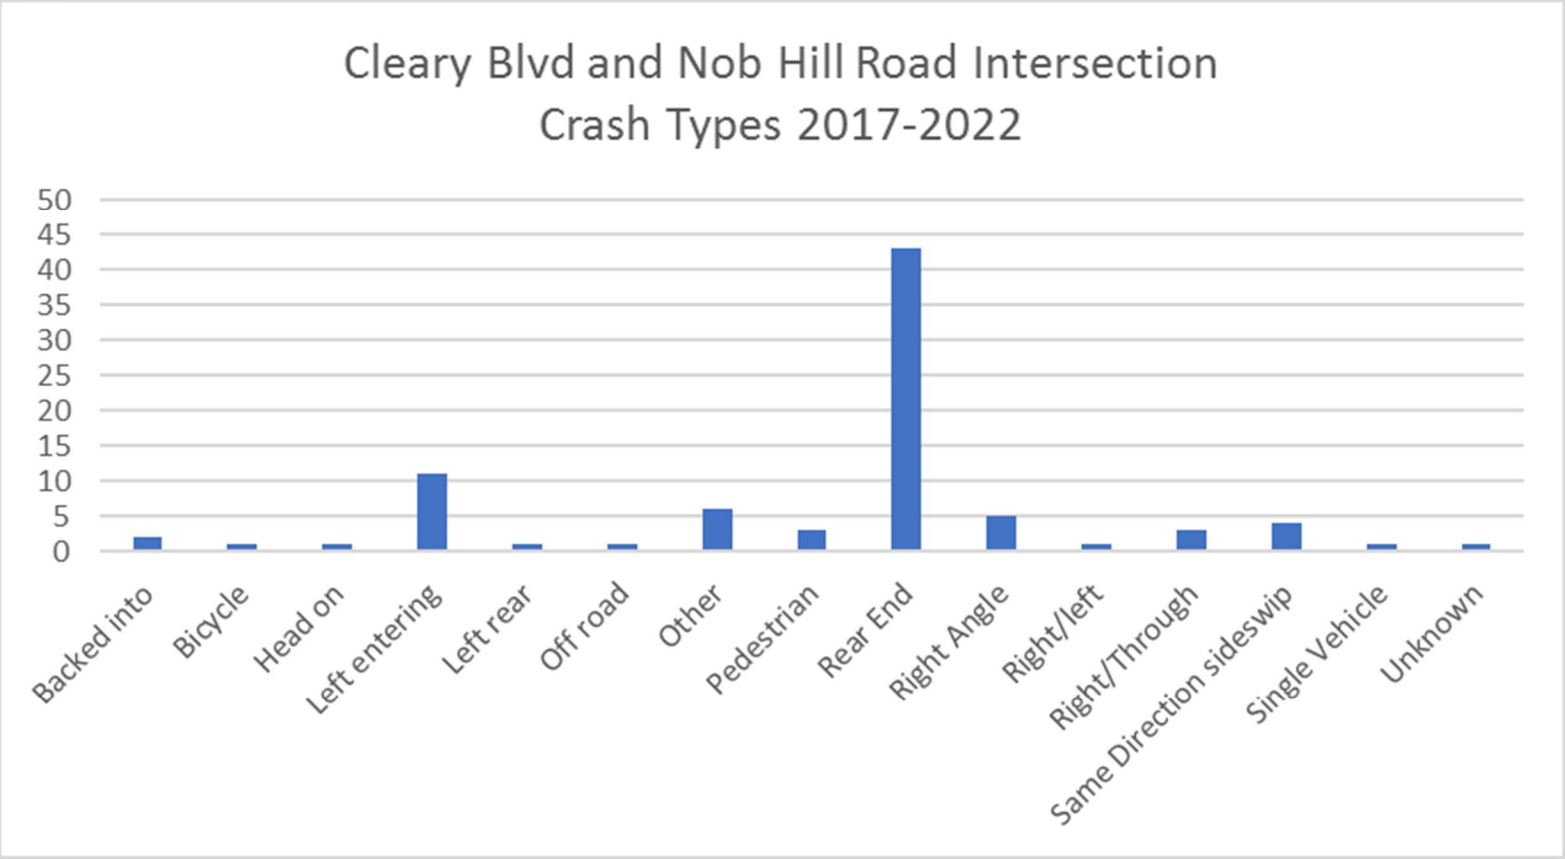
Figure 24: Crash types for Cleary Blvd and Nob Hill Road intersection

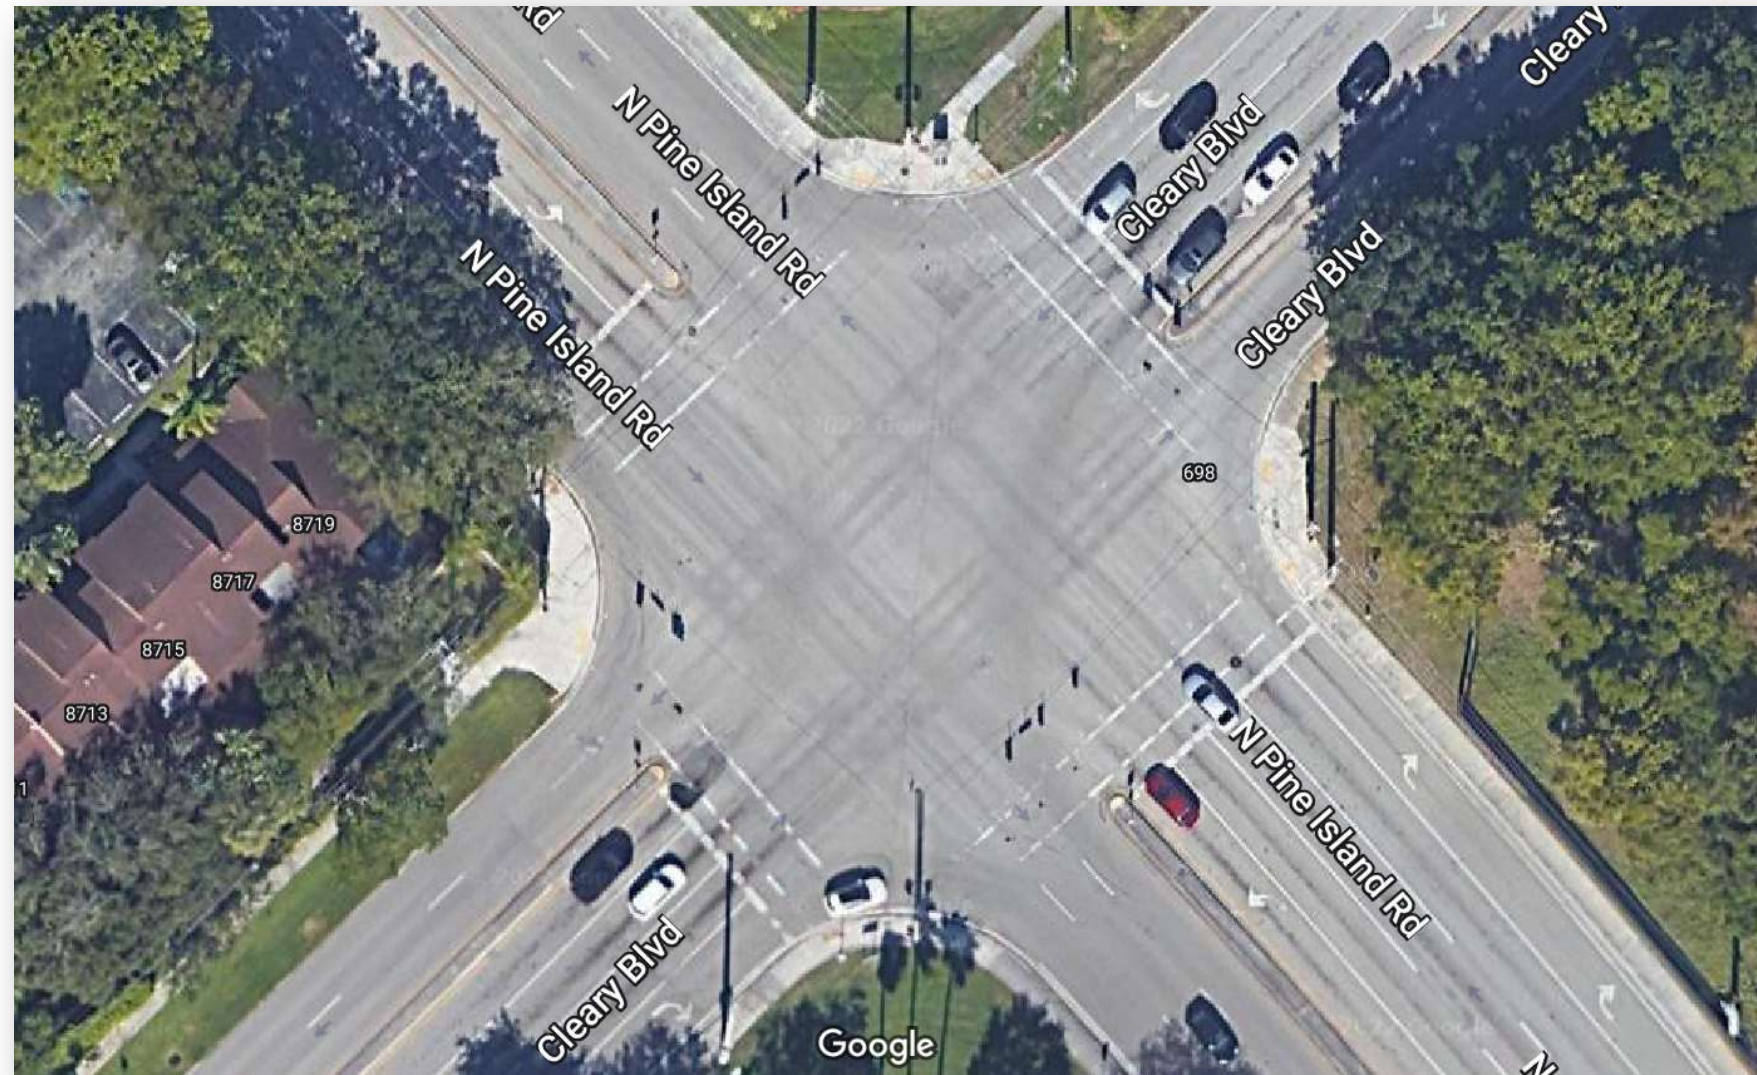
There were 92 total crashes at the Pine Island Road intersection. Rear end and left entering crashes were the most prominent. The intersection has a span wire signal, with left turn signals on all 4 legs. Pine Island Rd. is a County roadway.

Figure 25: Aerial of N. Pine Island Road intersection

6. Long distances between crosswalks adjacent to Sunset Park and Central Park may lead to pedestrians crossing mid-block.
7. There are pedestrian visibility issues at the intersection of Pine Island Road on western crosswalk. Also, pedestrian walk times seem short.

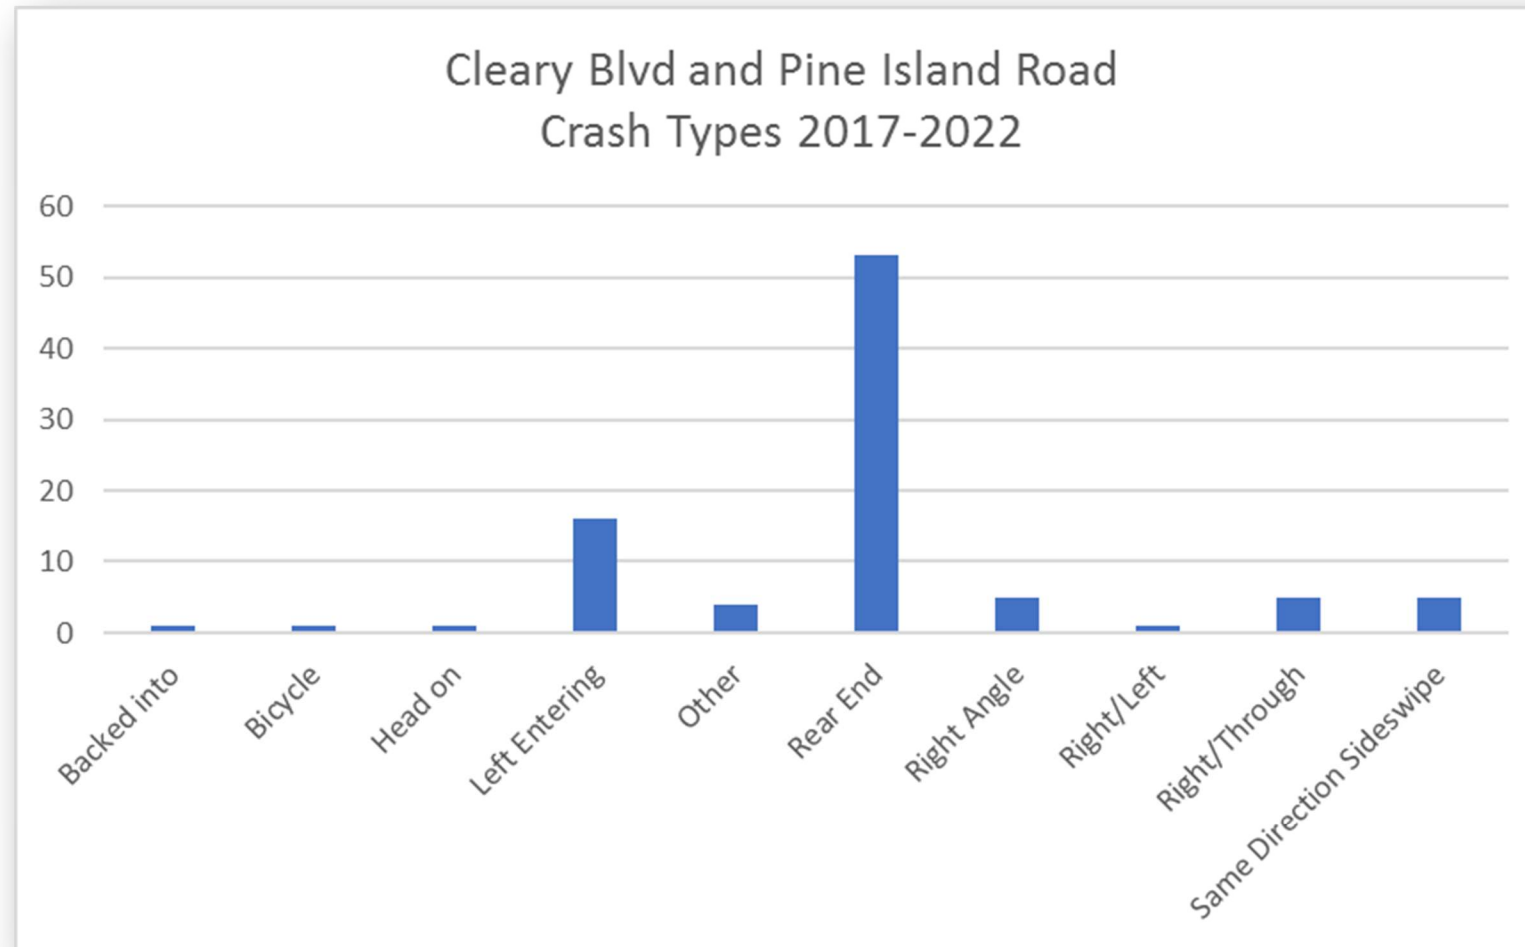
Figure 26: Crash types for Cleary Blvd and Pine Island Road intersection

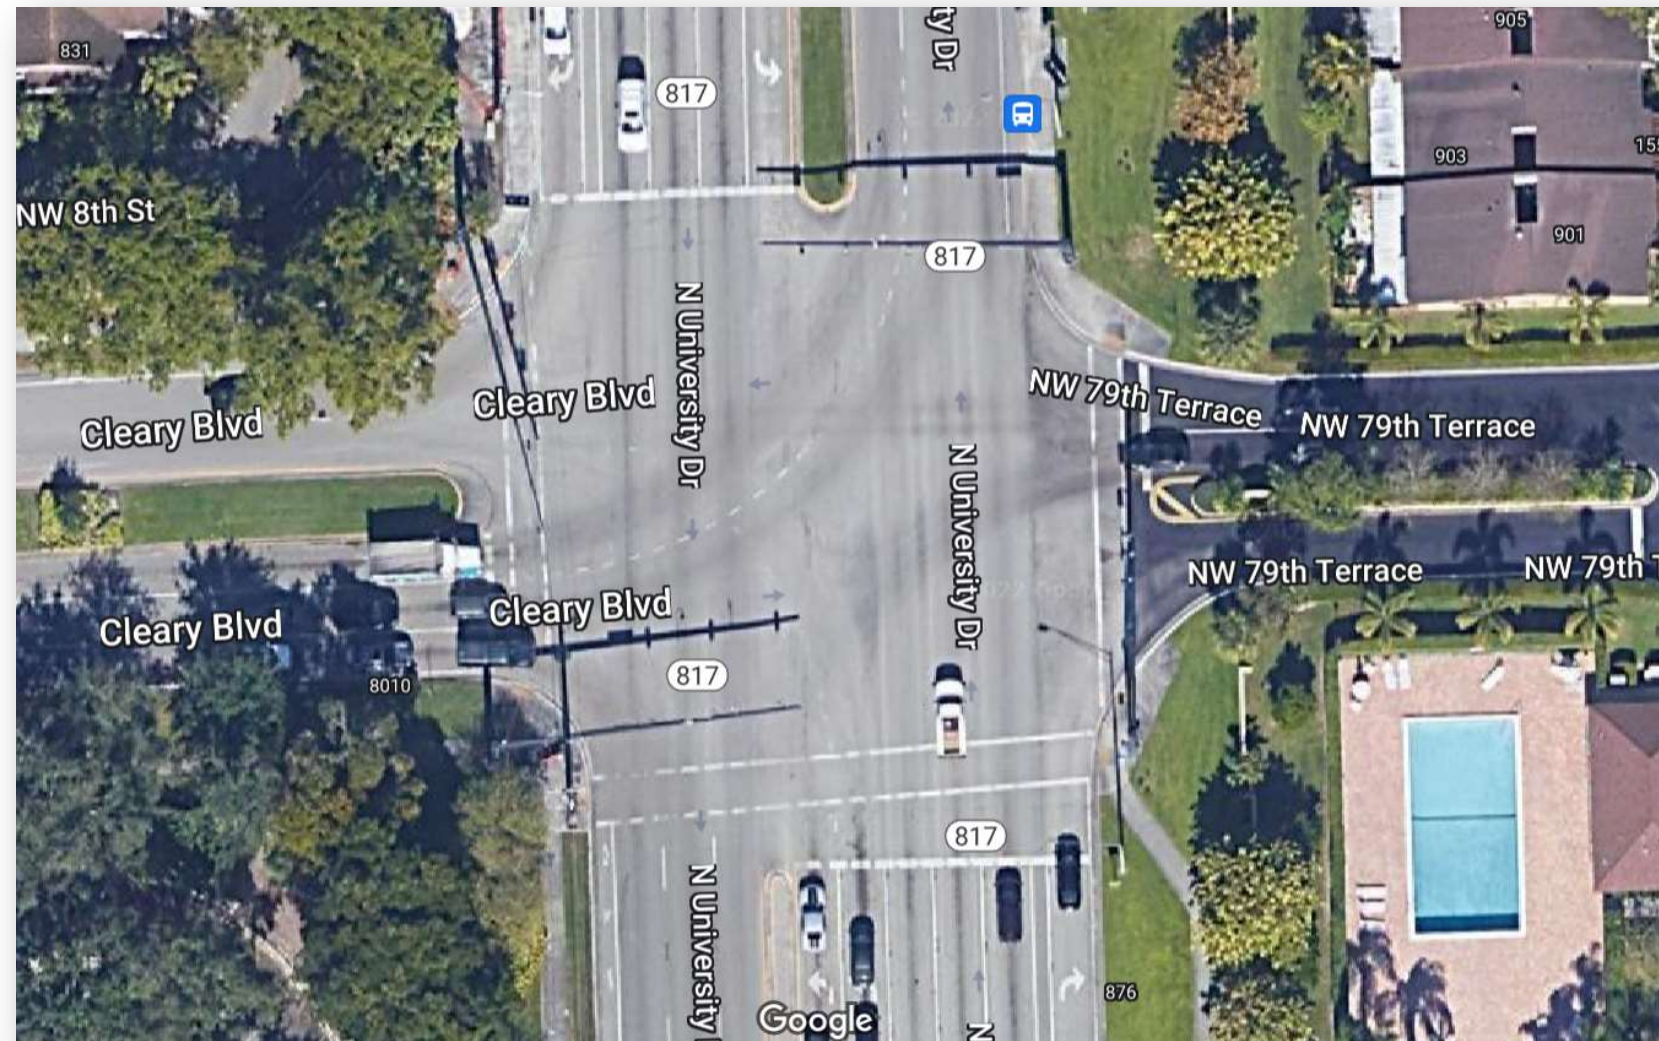
102 crashes occurred at the University Dr. intersection during the study period, the most of any intersection. Rear end crashes made up the vast majority of total crashes. There are mast arm signals installed at the intersection, with left turn signals on all 4 legs. University Dr. is an FDOT roadway.

Figure 27: Aerial of University Dr. intersection

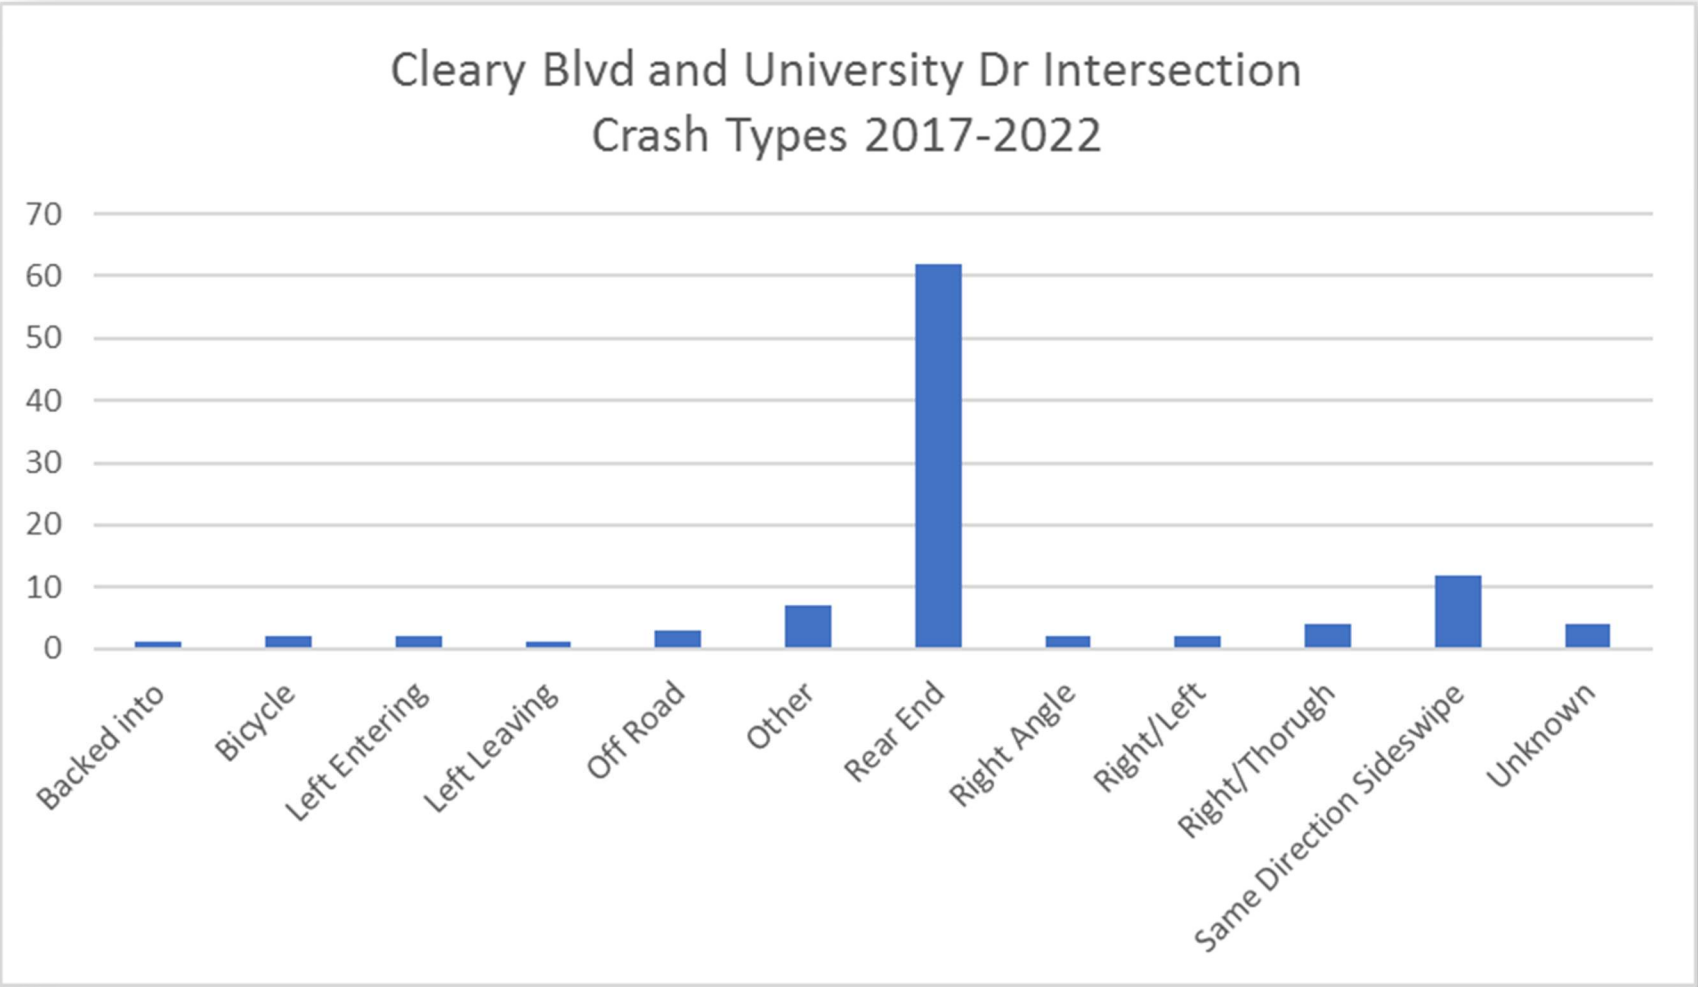
Figure 28: Crash types for Cleary Blvd and University Dr. Intersection
